INVESTIGATION OF SOLID CADMIUM EMBRITTLE-  
MENT IN A-7 AIRCRAFT FAILED SHAFTS AND  
HORN FRACTURE SURFACES

Vought Aeronautics Company

AFML-TR-72-249

January 1973

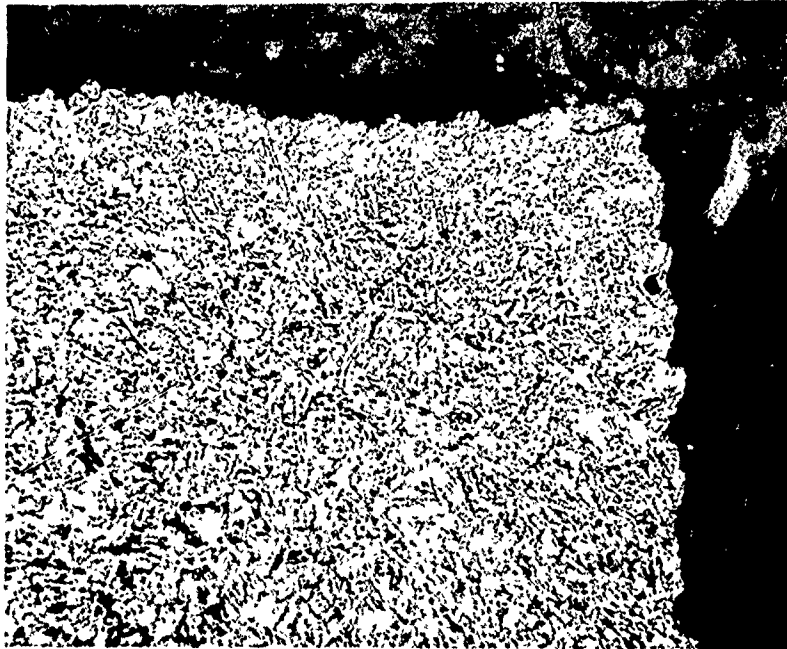
Figure 36. Cross-section Through Failure Origin of Shaft from A-7B-181. Perpendicular Crack Occured Inboard from Tapered Hole in the Transition Area from Intergranular to (Dimple) Rapid Fracture.

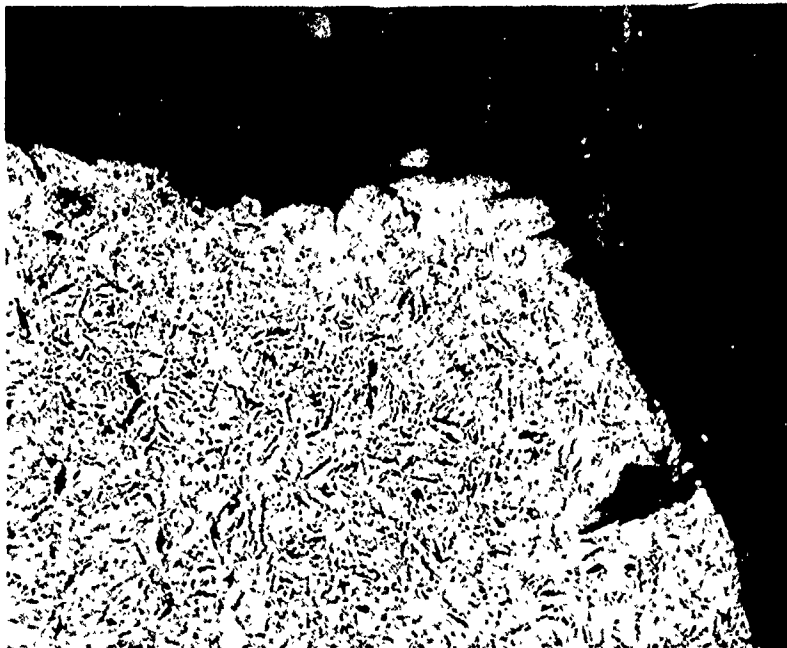
Figure 37. Cross Section of Failure Origin of Shaft From A-7D-8. There Appeared to Be Small Shear Lip at Extreme Edge of Origin Top-Right. Nital Etch

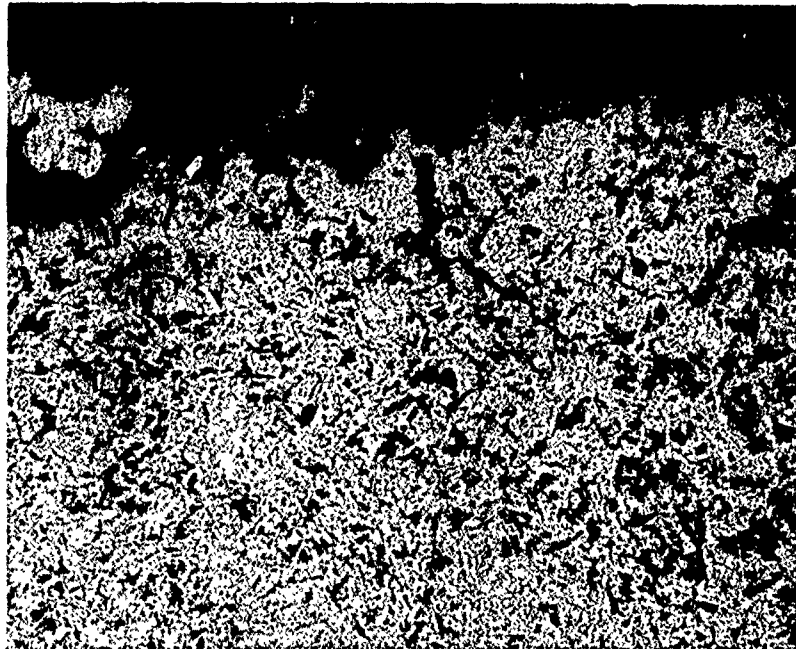
Figure 38. Cross-section of Failure Origin of Shaft from A-7B-121. Some Small Intergranular Cracking Can Be Seen Associated with Fracture. This Origin (Top Right) Had Been Damaged During Failure. Nital Etch

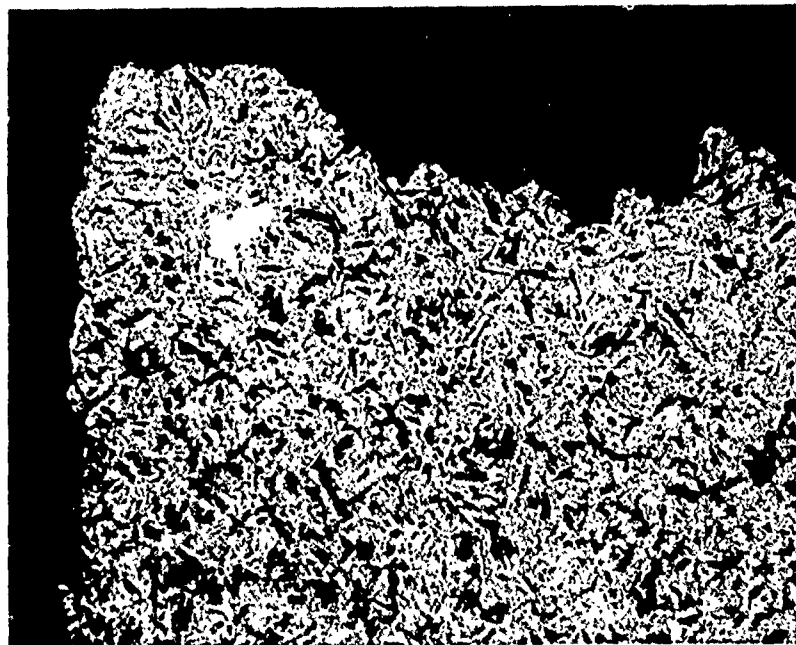
Figure 39. Cross-section of Failure Origin of Shaft from A-7B-107. Intergranular Cracks Were Associated with TE Fracture Surface in the Intergranular. Nucleus Area. Nital Etch

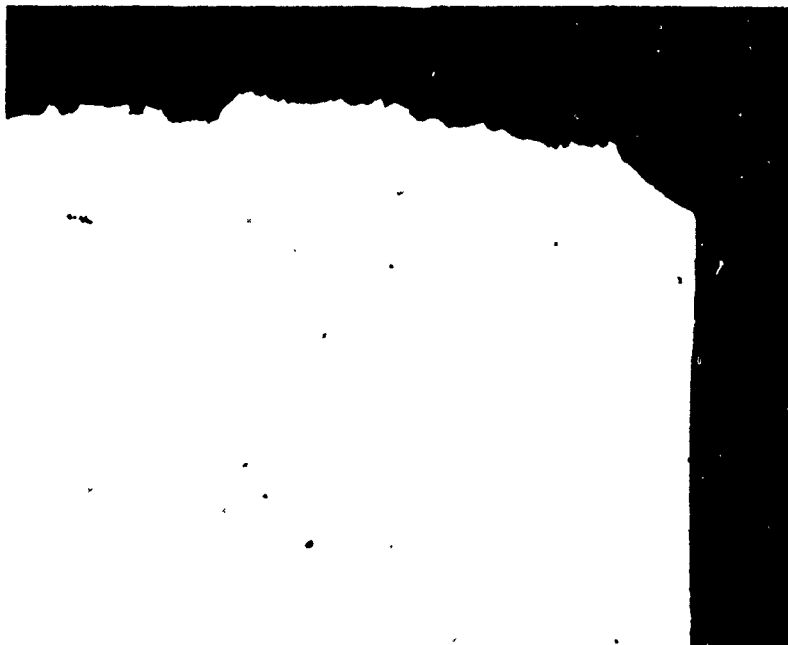
Figure 40. Cross-section of Failure Origin of Shaft from A-7B-183. No Evidence of Secondary Cracking Propagating from the Tapered Hole (Left) Was Observed on Any of the Surface Failures. Nital Etch

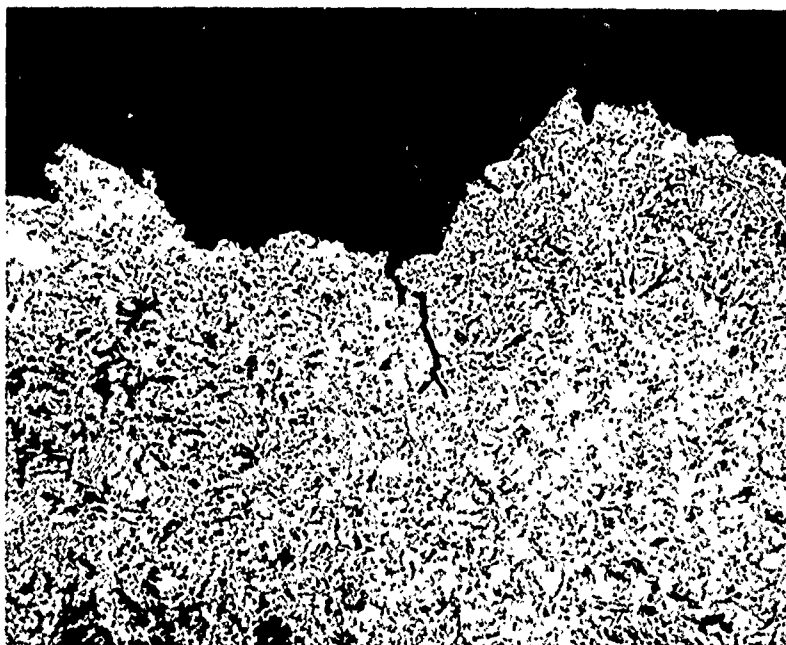
Figure 41. Cross-section of Failure Origin of Horn from A-7B-183.  
A Shear Lip Can Be Seen at the Origin (Top Right).  
Small Minute Cracks Are Present in the Intergranular Nucleus Area.  
Unetched

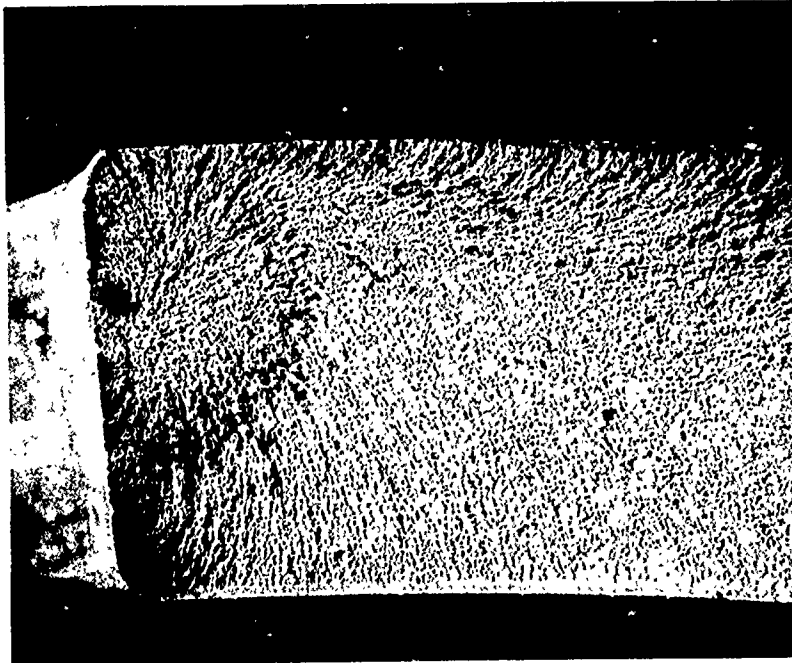
Figure 44. Photomacrograph of The Fracture Surface of The Simulated Shaft After Induced Failure. The Fracture Depicts Only Tension and Shear Modes. No Evidence of Cadmium Cracking Was Observed.

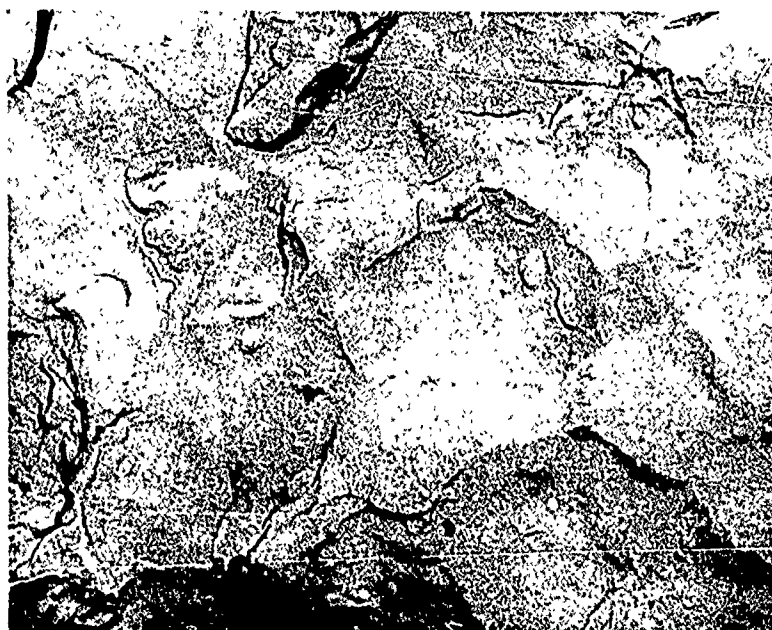
Figure 51. Fracture Origin on a UHT Horn from A-7B-183.

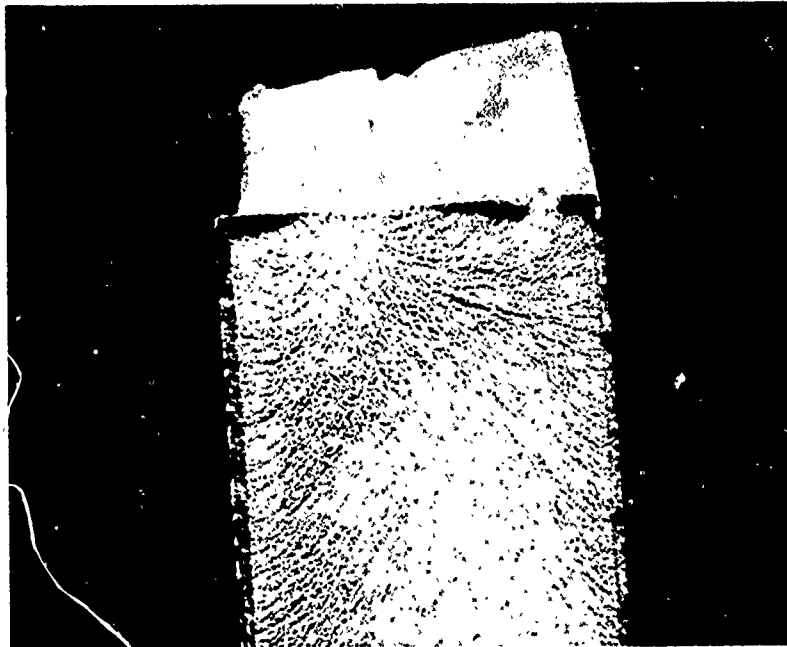
Figure 53. Fracture Origin on UHT Shaft from A-7D-8
